REPORT R-1677

# FRANKFORD ARSENAL

DELAYED FRACTURE OF ALUMINUM ALLOYS BY  
LIQUID ZINC AMALGAM

APRIL 1963

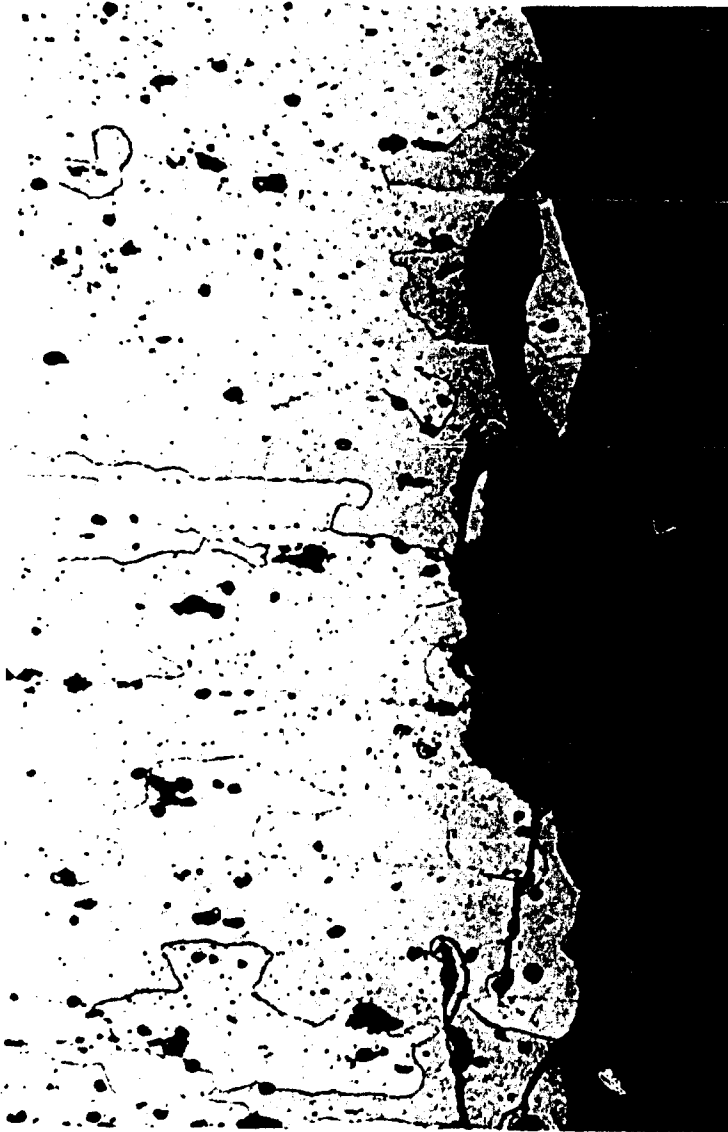
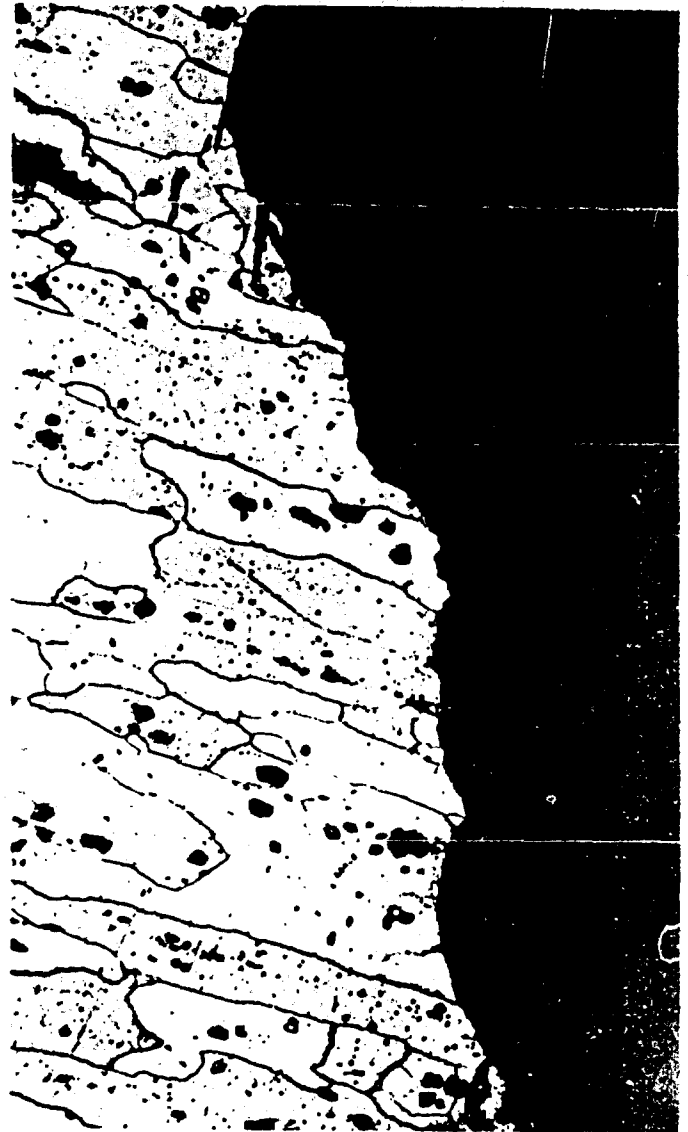
Figure 5. Photomicrographs of failed edges of 1/16 in. thick 2024 T-3 aluminum after having been wetted with 2% Zn - Hg amalgam and stressed to failure. Note lack of cold work or distortion along failure.

Microstructural examinations were made of specimens from alloys 2024 and 7075 in the age hardened states upon embrittlement with the zinc amalgam. No evidence of deformation was seen at the fractured edges (see figures 5 and 6). This observation is typical of true embrittlement and is in agreement with the work of other investigators<sup>(2)</sup> which showed no noticeable distortion along the fractured edges of embrittled twin crystals of brass (see figure 7).

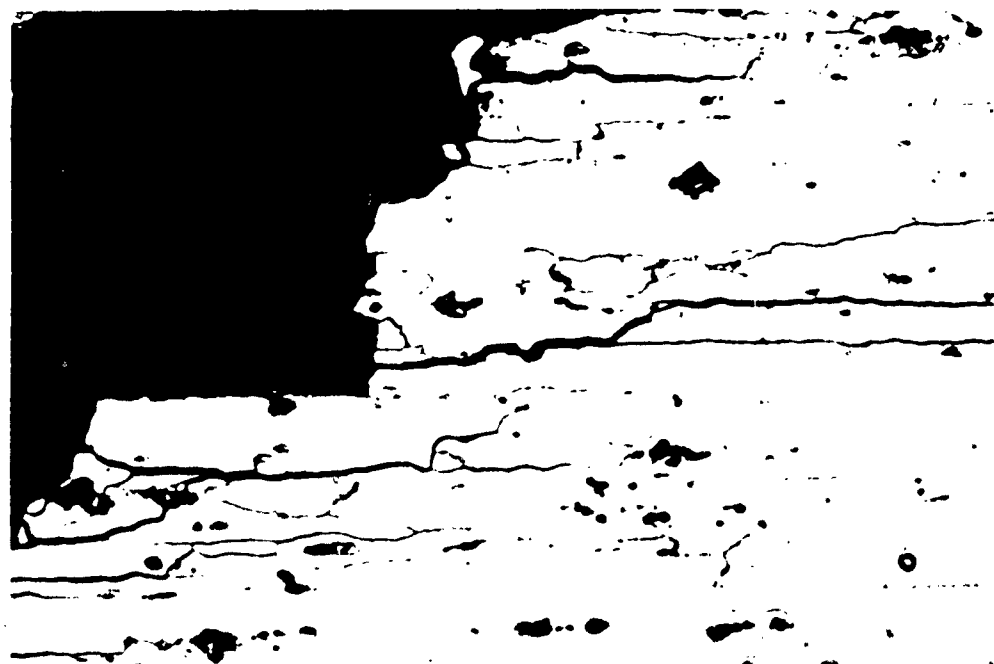
Figure 6. Photomicrographs showing failed edges of aluminum alloy 7075 T-6 which had been wetted mechanically with 2% Zn - Hg amalgam. Note crack propagation pattern and lack of distortion along failed edges.

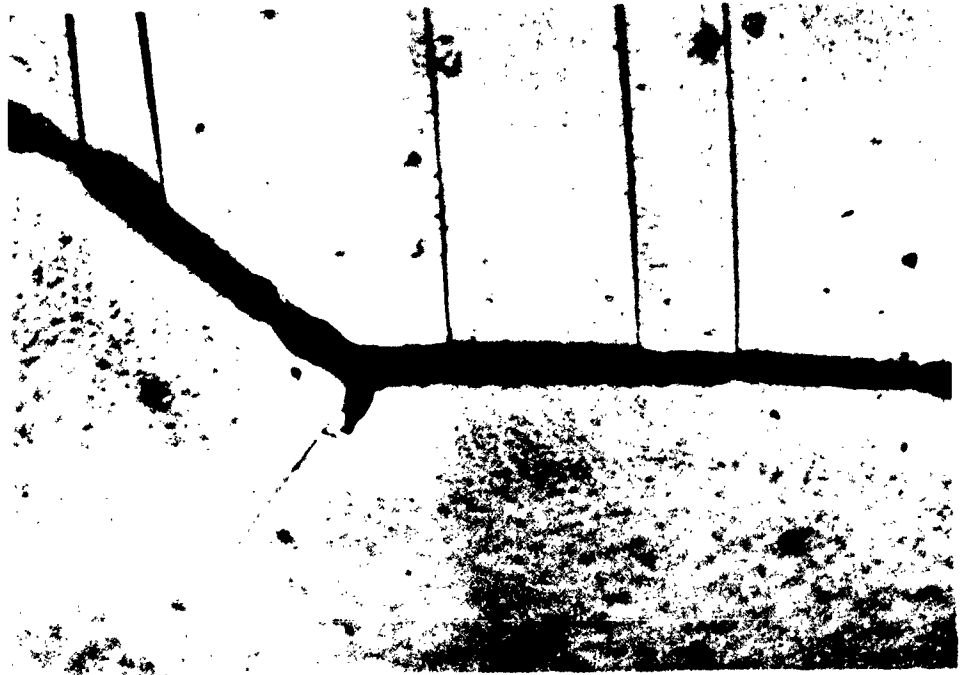
Figure 7. Intersection of twin interfaces with an intergranular crack in 70/30 brass embrittled by wetting with mercury. (After Rostoker<sup>2</sup>)

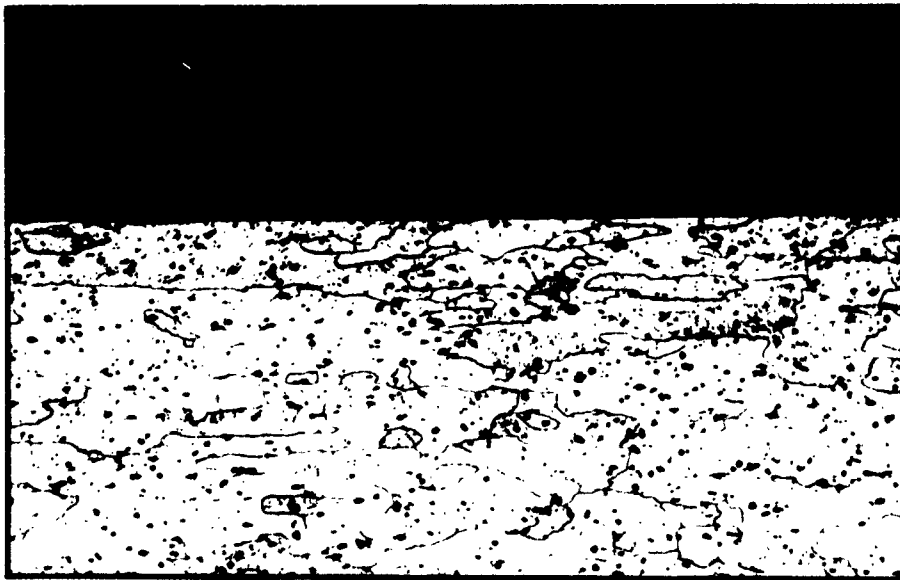
Figure 11. Photomicrographs depicting edge of 1/16 in. thick 2024 T-3 aluminum which had been wetted with 2% Zn - Hg amalgam and probe and then dewetted immediately. Transverse to rolling direction. Magnification 200X.

That delayed fracture is not the result of a continued chemical attack of the aluminum by the liquid amalgam was shown in two ways. Specimens from alloy 2024 T-3 were wetted with amalgam using the ultrasonic probe and were then dewetted immediately by washing with water. The pieces were then subjected to microscopic examination to detect the extent of any possible amalgam penetration. As shown in the photomicrographs, see figure 11, no penetration was evident within the resolution of the microscopic equipment used.
